Miscellaneous Paper CERC-96-3  
May 1996

# Physical Model Study of Breakwater Stability, Kodiak, Alaska

Prepared for U.S. Army Engineer District, Alaska

**Final report**

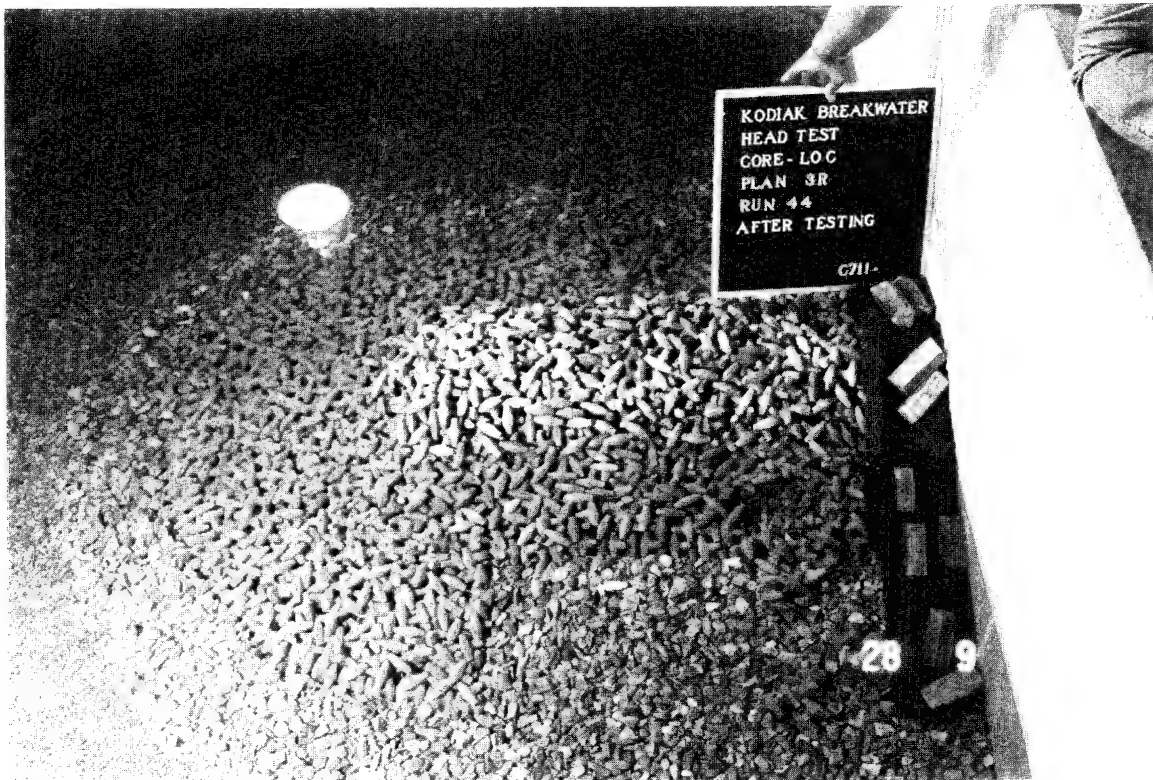
Photo 16. Damage sustained by model breakwater during demonstration runs of Plan 3R

The model next was tested with 48-min runs at  $T_p = 11.0$  sec and  $H_{m0} = 2.4$  m (8.0 ft). No movement was observed during the first run, but a hole in the Core-Locs was washed out during the second run. The hole developed suddenly when several Core-Locs were washed out of the matrix on the harbor-side trunk between swl at +3.2 m (+10.5 ft) mllw and the toe of the Core-Locs above the B-stone at 0.0 m (0.0 ft) mllw. All tests were halted at this point to allow the structure to be viewed by personnel visiting from NPA. Photo 16 shows damage that occurred to Plan 3R during the second run at  $T_p = 11.0$  sec and  $H_{m0} = 2.4$  m (8.0 ft).

At swl = +3.2 m (+10.5 ft) mllw, a short demonstration run was conducted at  $T_p = 14$  sec and  $H_{m0} = 1.7$  m (5.5 ft) with no noticeable movement on the structure, but the structure failed during a test at  $T_p = 14$  sec and  $H_{m0} = 2.1$  m (7.0 ft). Heavy overtopping caused armor units on the harbor-side trunk above swl to slough, exposing the underlayer.

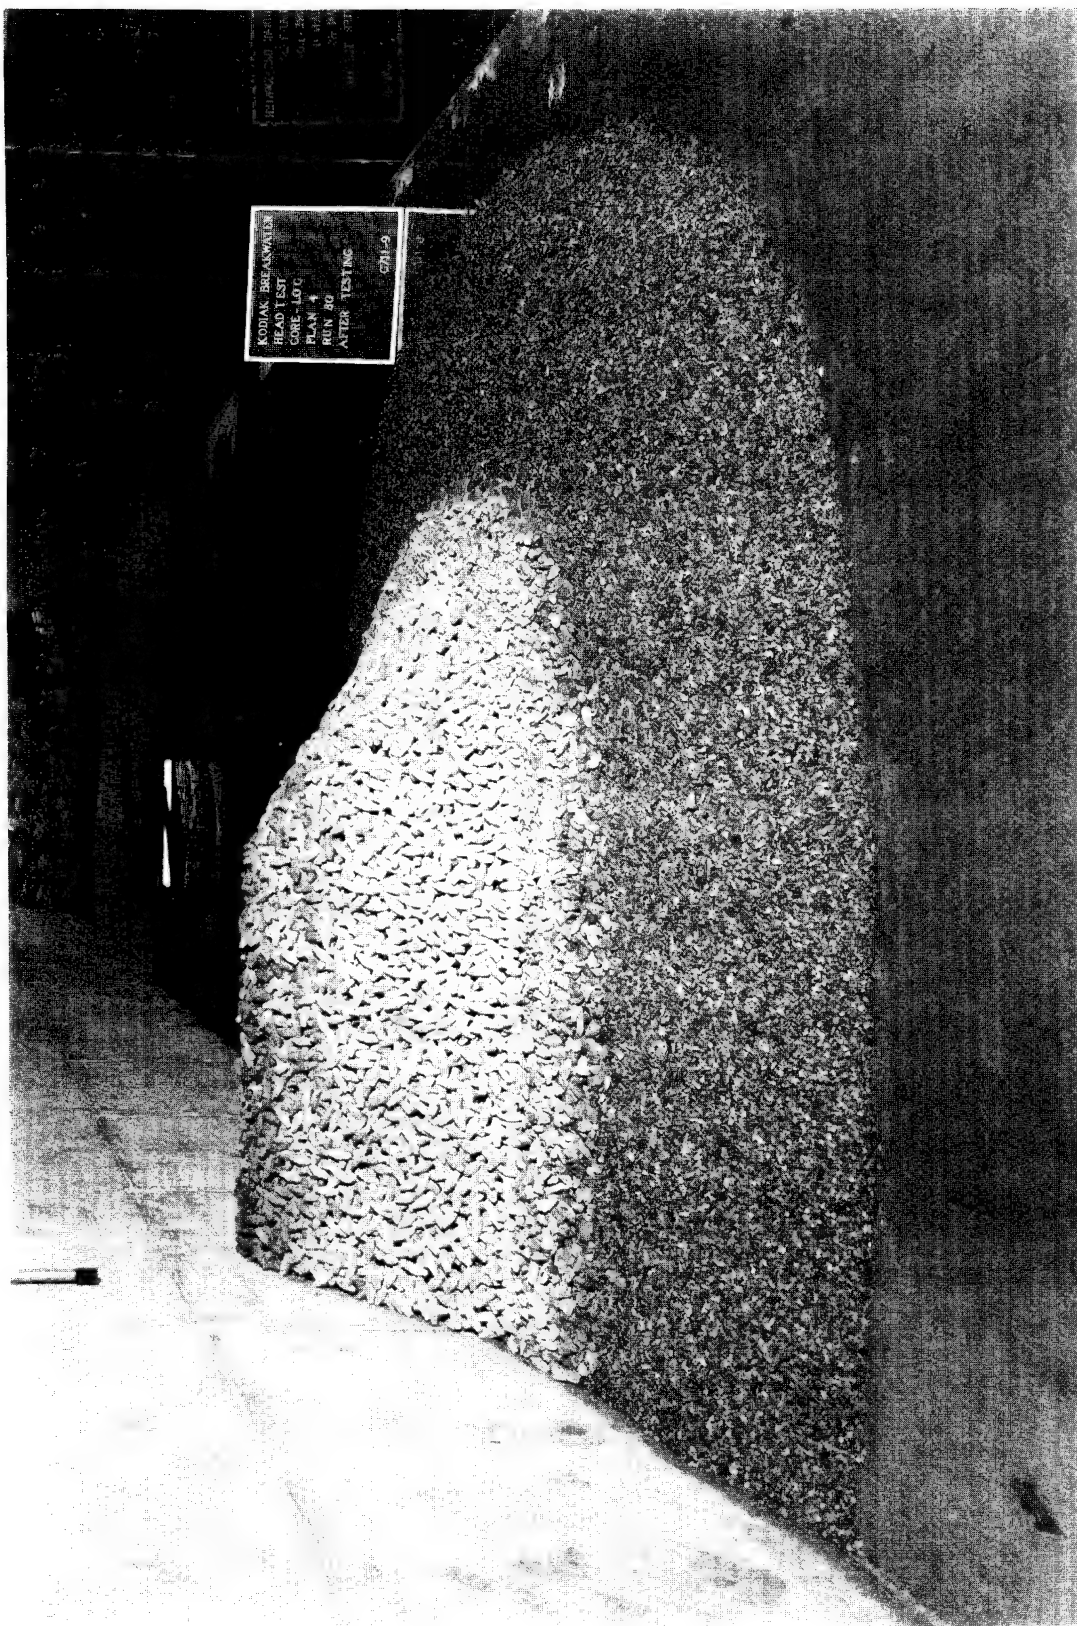
Photo 17. Sea-side view of model breakwater Plan 4 after testing

Photos 17, 18, and 19 show sea-side, end, and harbor-side views, respectively, of Plan 4 after testing.

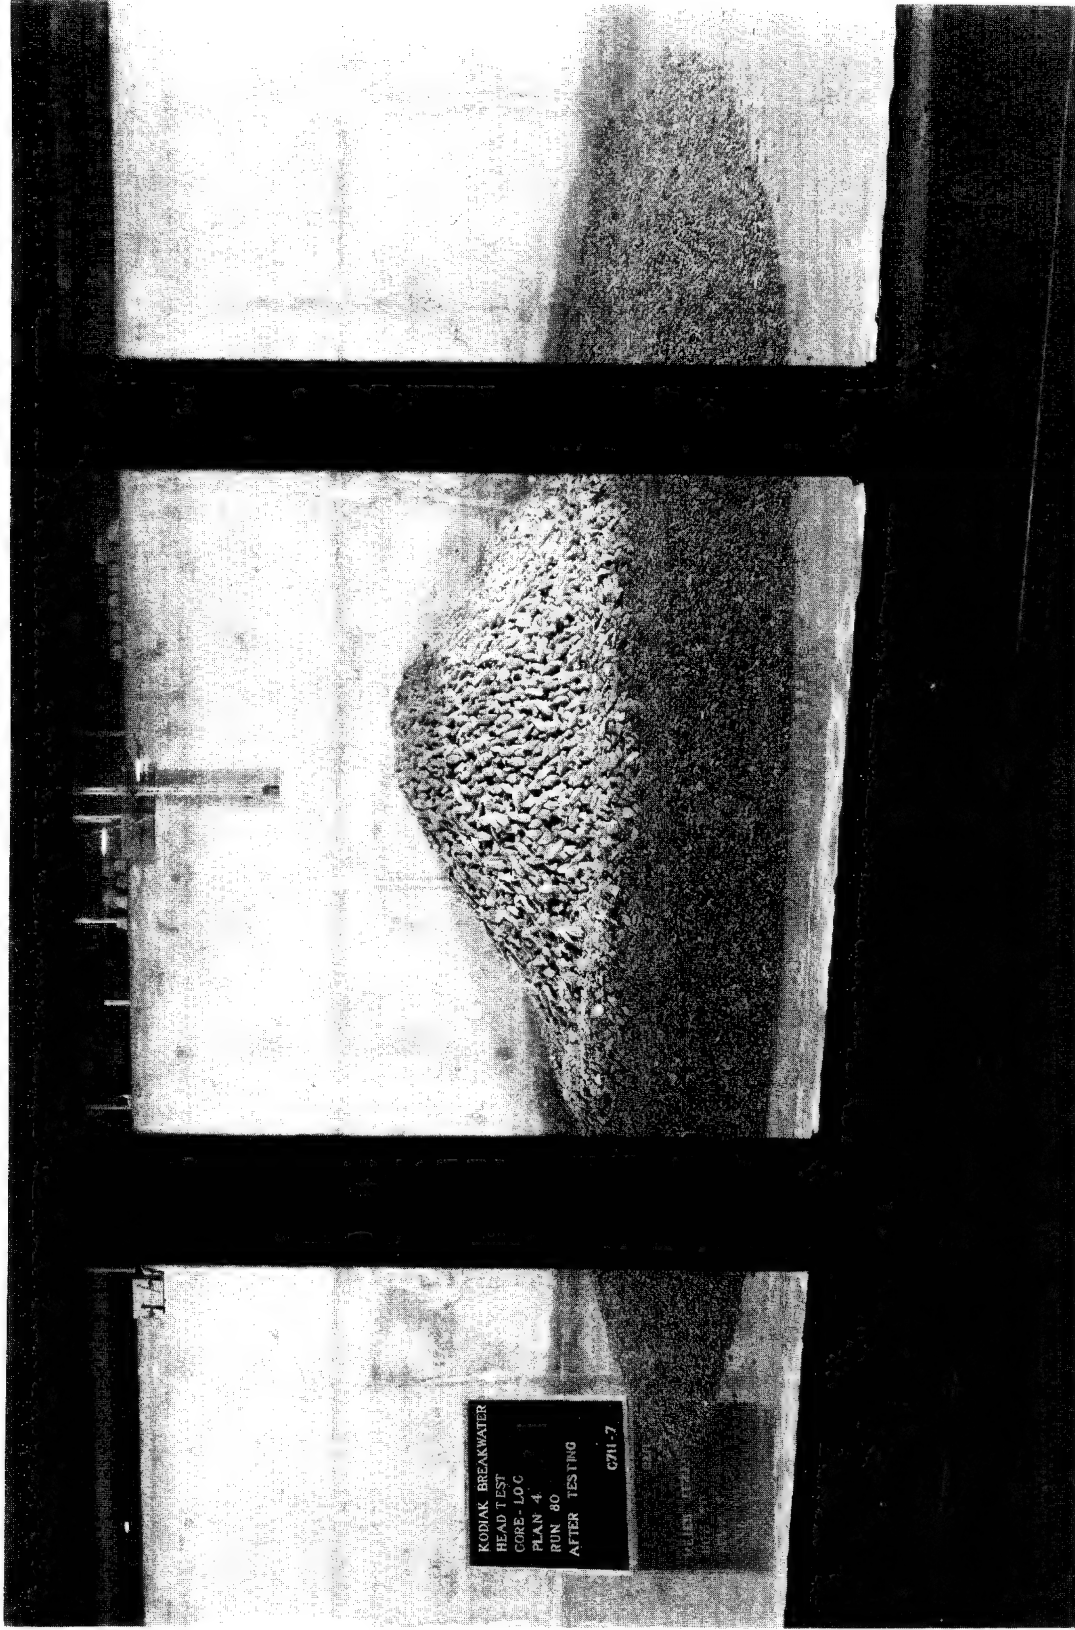
Photo 18. End view of model breakwater Plan 4 after testing

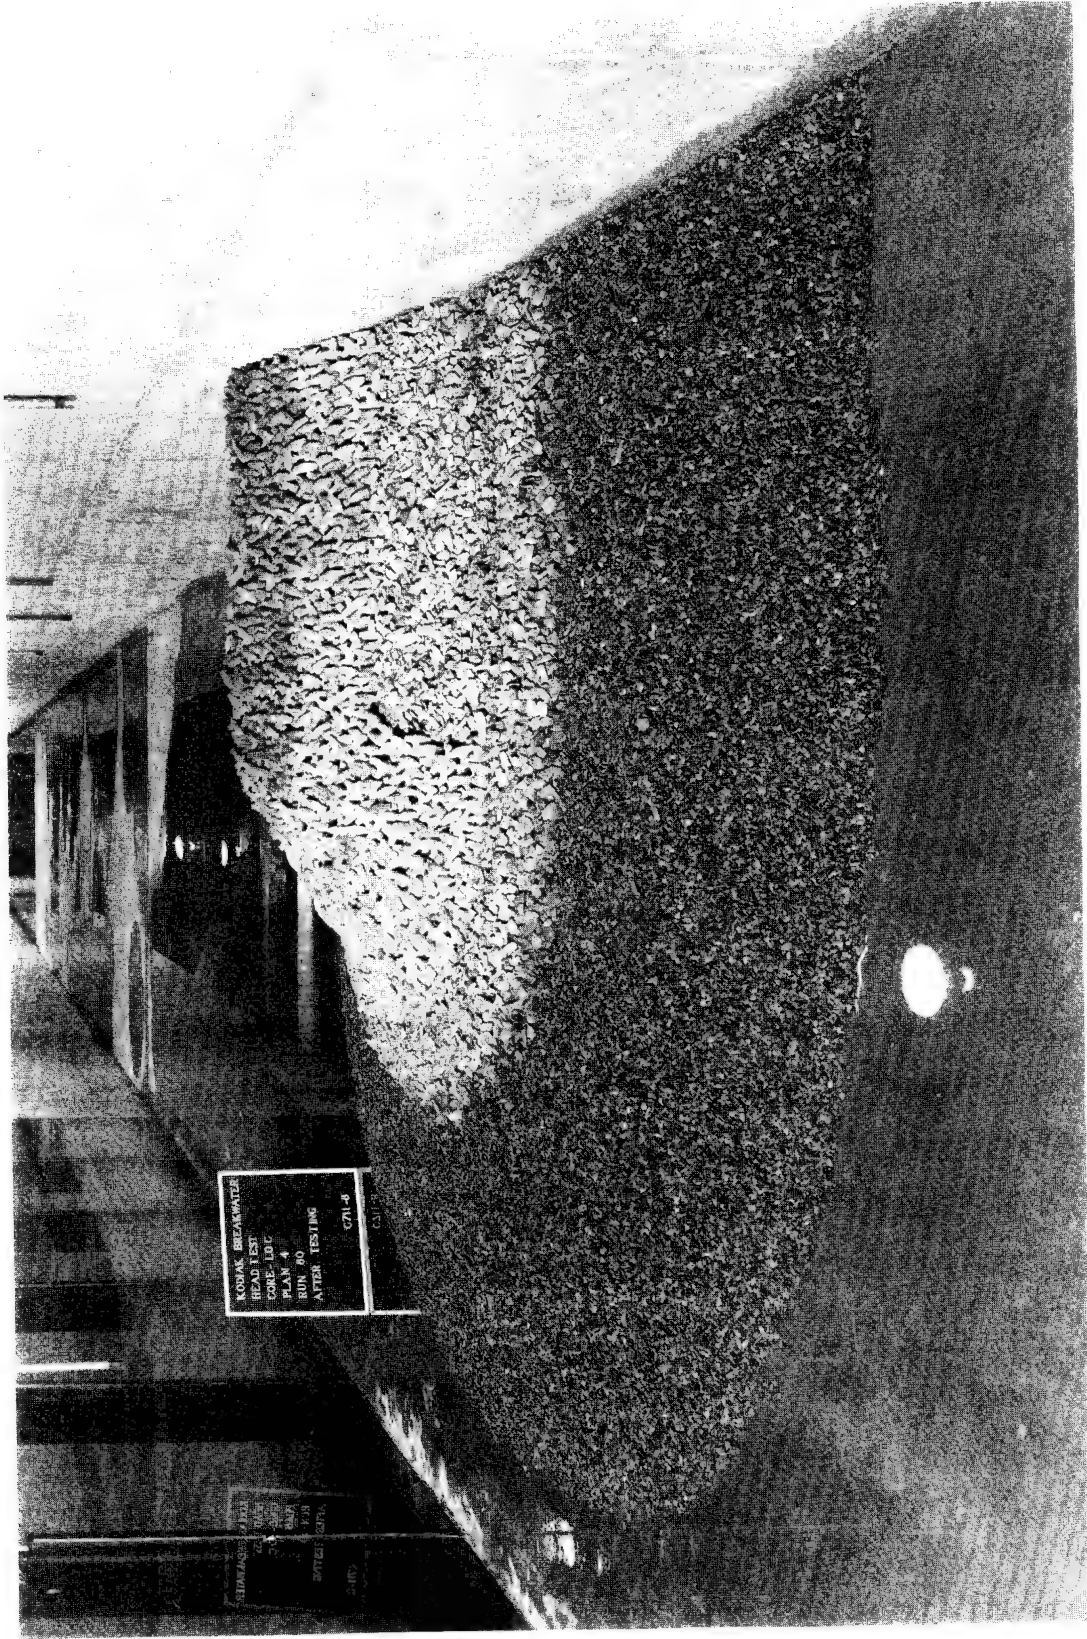
Photo 19. Harbor-side view of model breakwater Plan 4 after testing

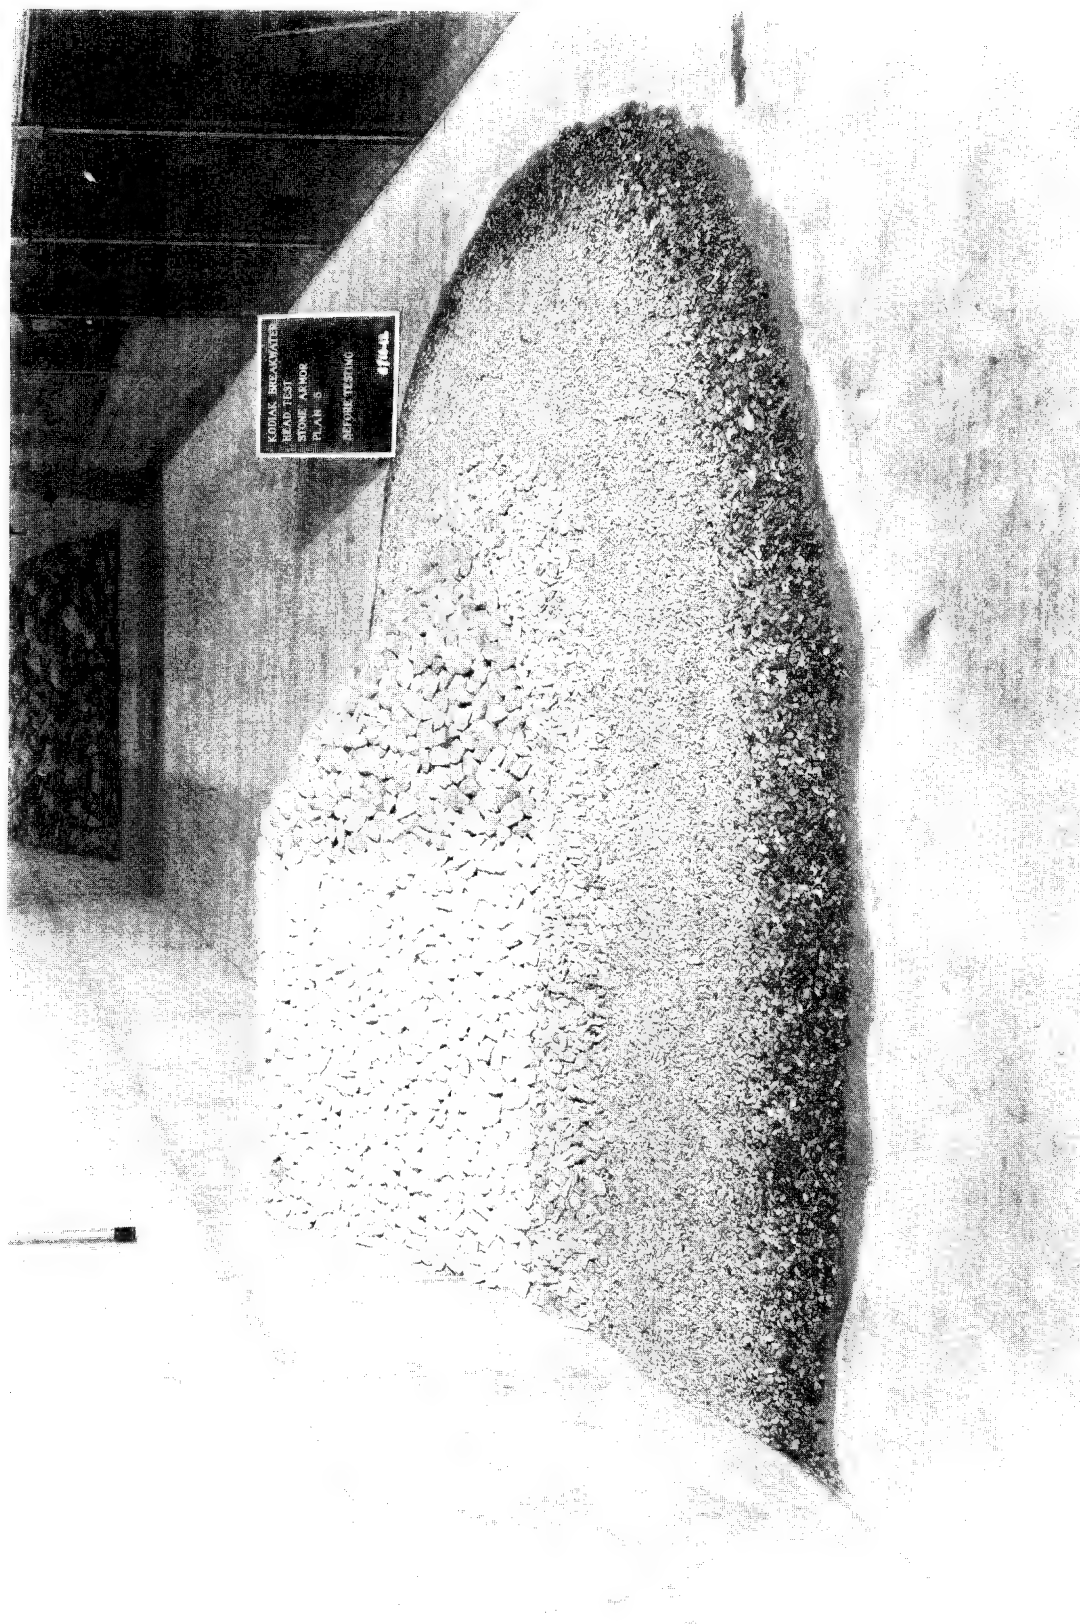
Photo 20. Sea-side view of model breakwater Plan 5 before testing

Plan 5 used armor stone instead of Core-Locs for primary armoring of the structure. All Core-Locs were removed from the structure and the underlayer was smoothed and reshaped as necessary. A double layer of armor stone with  $W_{50} = 1,450$  kg (3,200 lb) was placed over the B-stone underlayer. Crest elevations of the structure core and underlayer were the same as in Plans 1, 2, 3, and 4, but the double layer of armor stones raised the final crest elevation higher than the single layer of Core-Locs used on earlier test configurations. Stones were placed in a manner similar to dropping each stone individually from a backhoe, and no attempt was made to specially place or key the stones. Stones used on the model were more uniform in size than would be expected on the prototype, with model stones typically within  $\pm 10$  percent of  $W_{50}$ . Figure 8 shows a cross section of the Plan 5 trunk; Figure 9 shows a cross section of the Plan 5 head. The vertical panels of rubberized matting used in Plan 4 were used again in Plan 5. Photos 20, 21, and 22 show sea-side, end, and harbor-side views, respectively, of Plan 5 before testing.

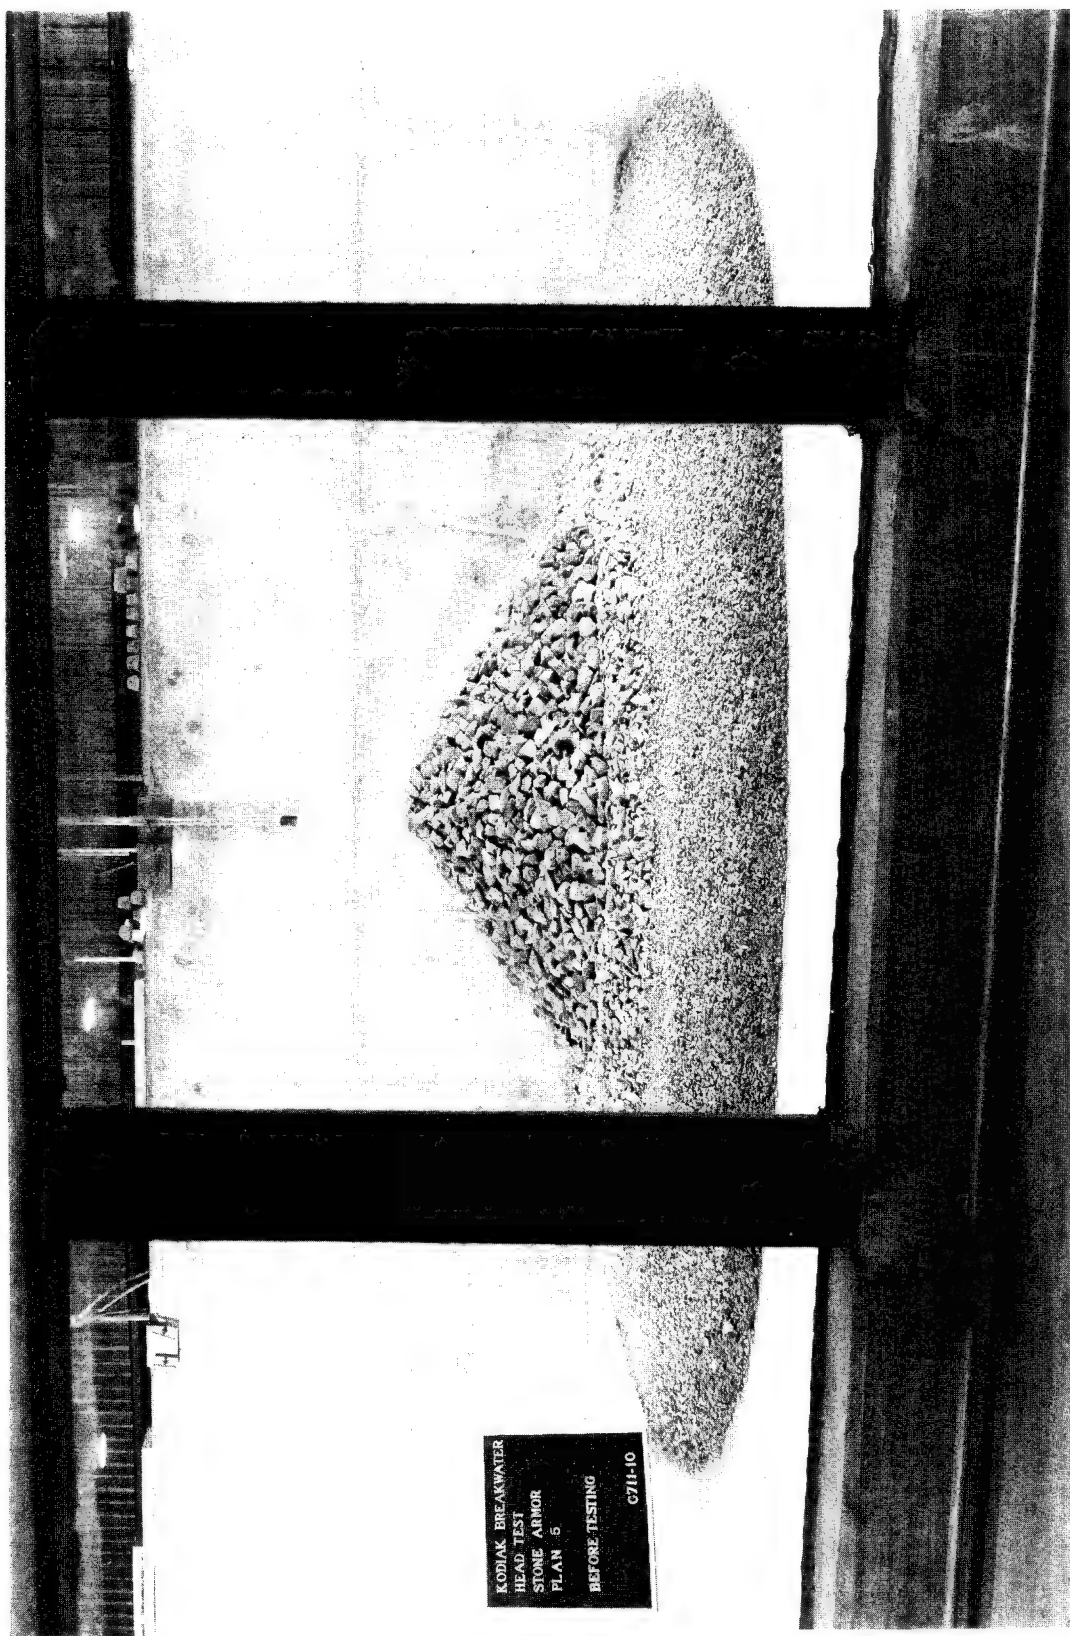
Photo 21. End view of model breakwater Plan 5 before testing

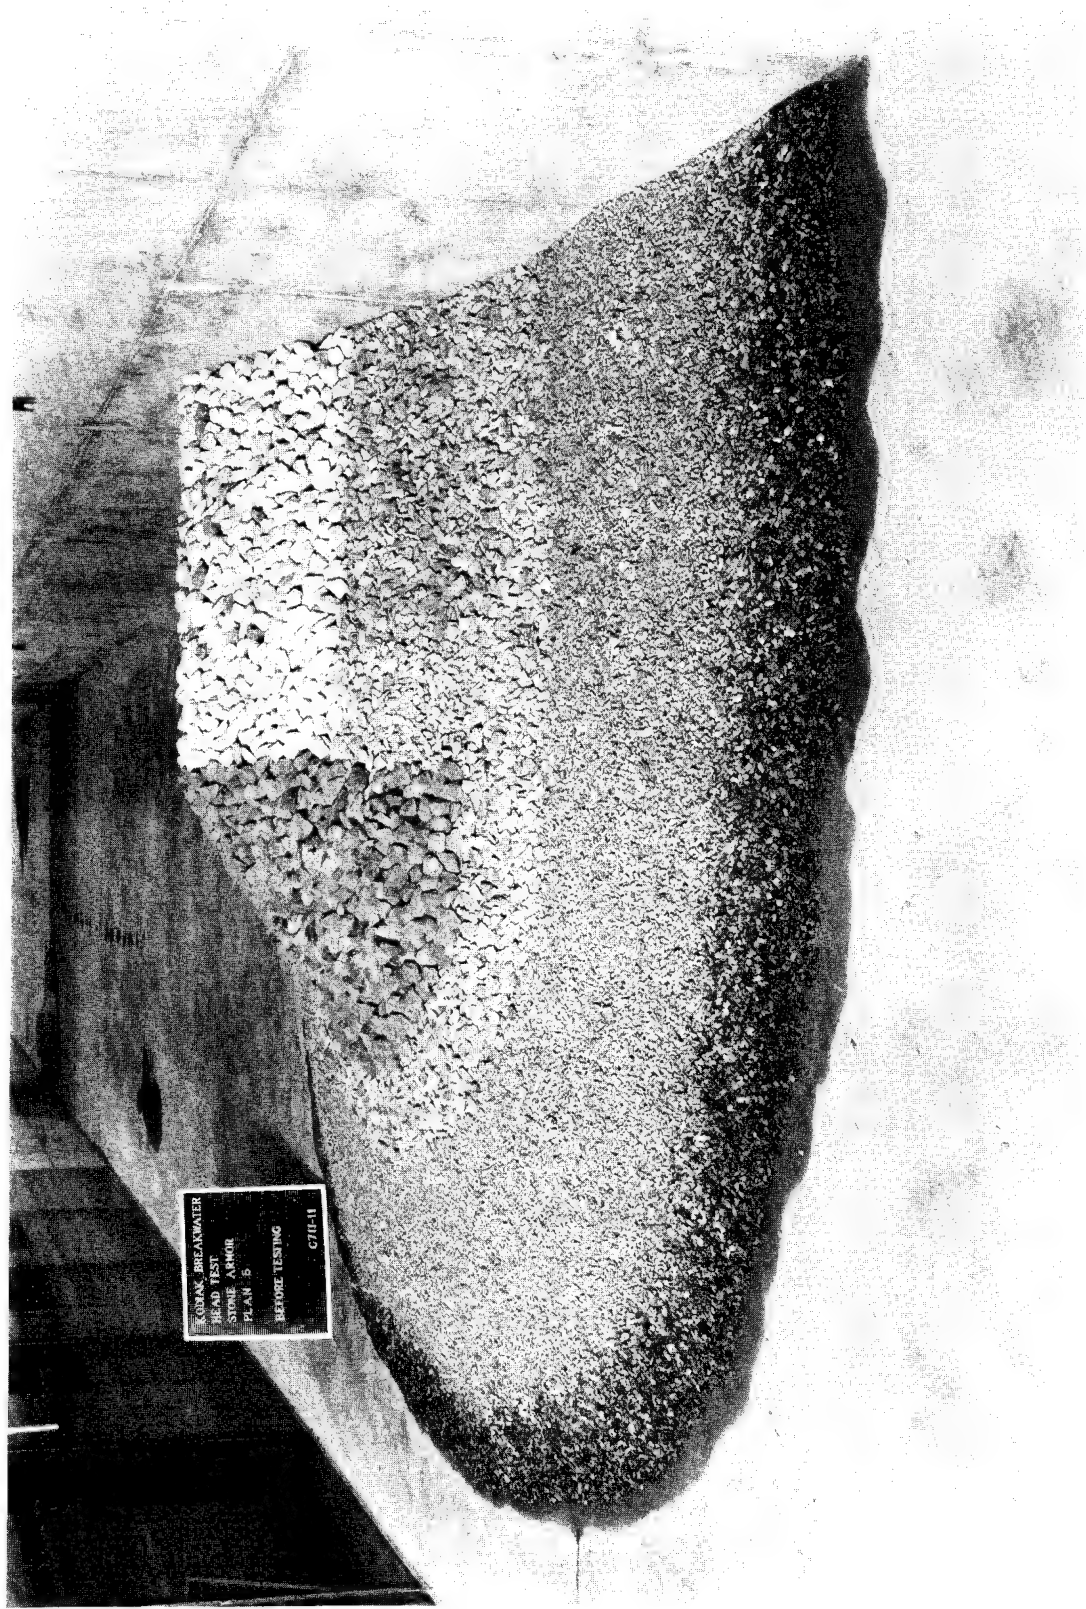
Photo 22. Harbor-side view of model breakwater Plan 5 before testing

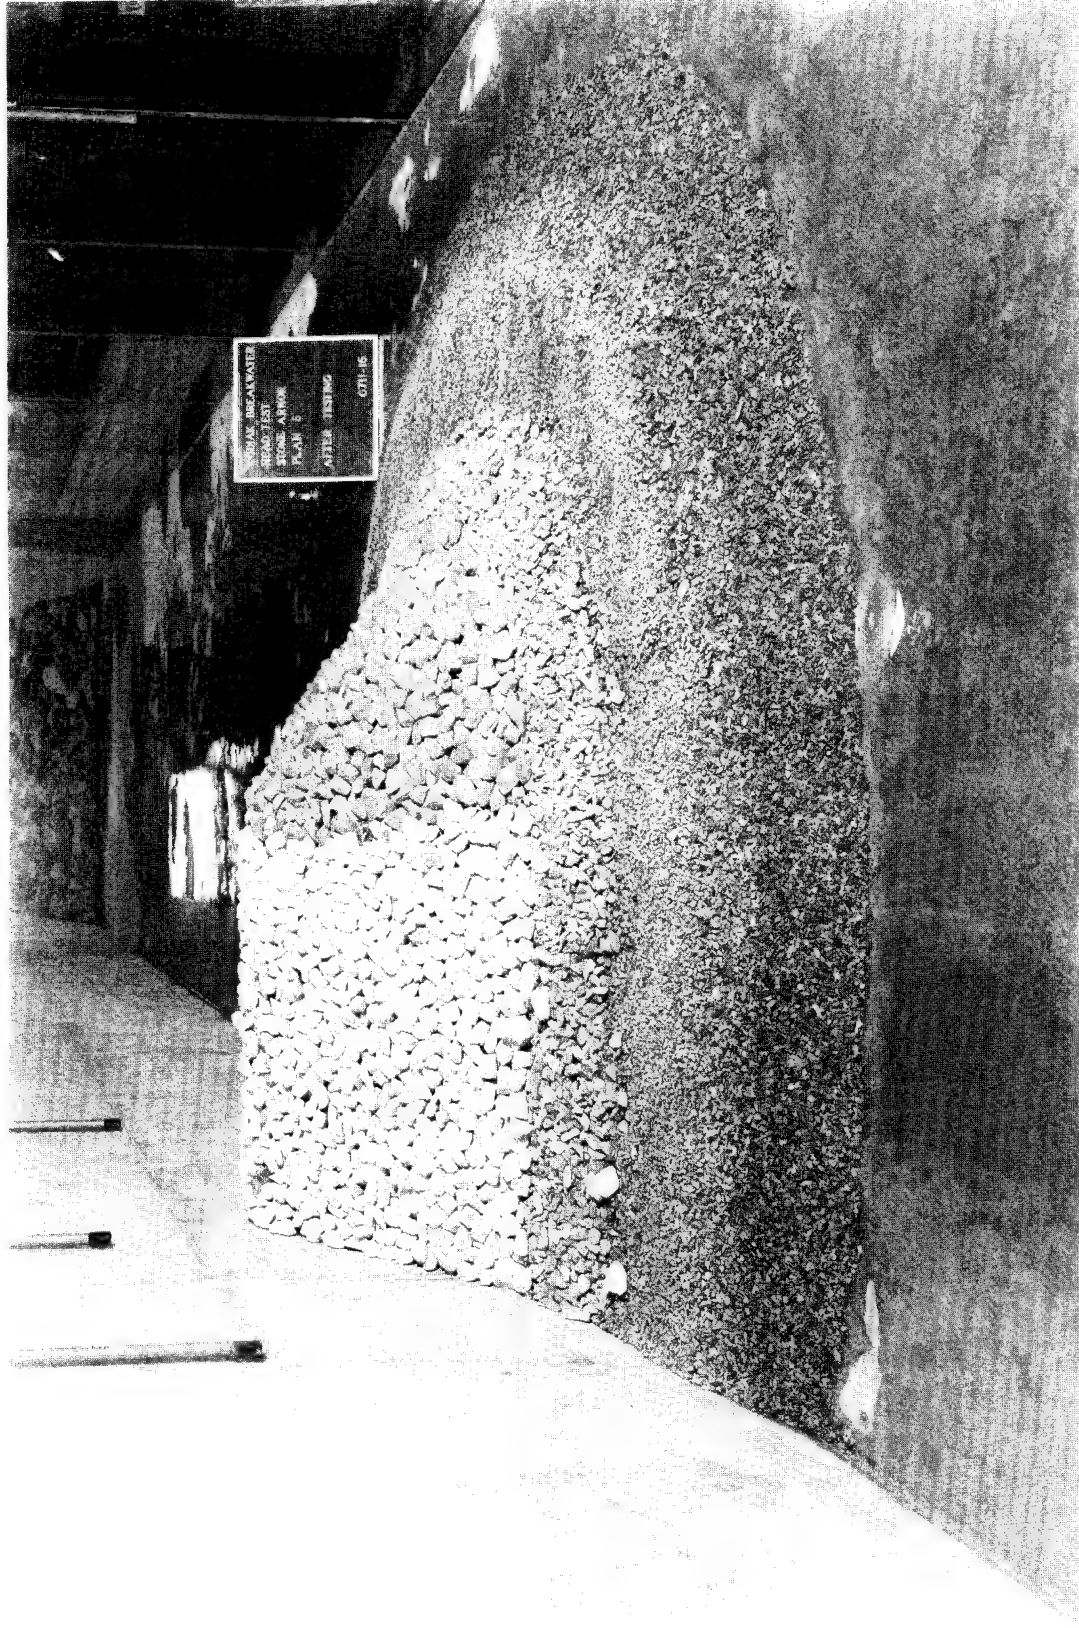
Photo 23. Sea-side view of model breakwater Plan 5 after testing

Water surface elevation next was lowered to 0.0 m (0.0 ft) mllw to test toe stability. Three test runs of 48-min duration each were conducted with  $T_p = 14$  sec and  $H_{m0} = 1.7$  m (5.5 ft). During the course of the three tests, three stones were dislodged from the slope on the head and one from the sea-side trunk. The structure remained in stable condition. Photos 23, 24, and 25 show the sea side, end view, and harbor side, respectively, of Plan 5 after testing.

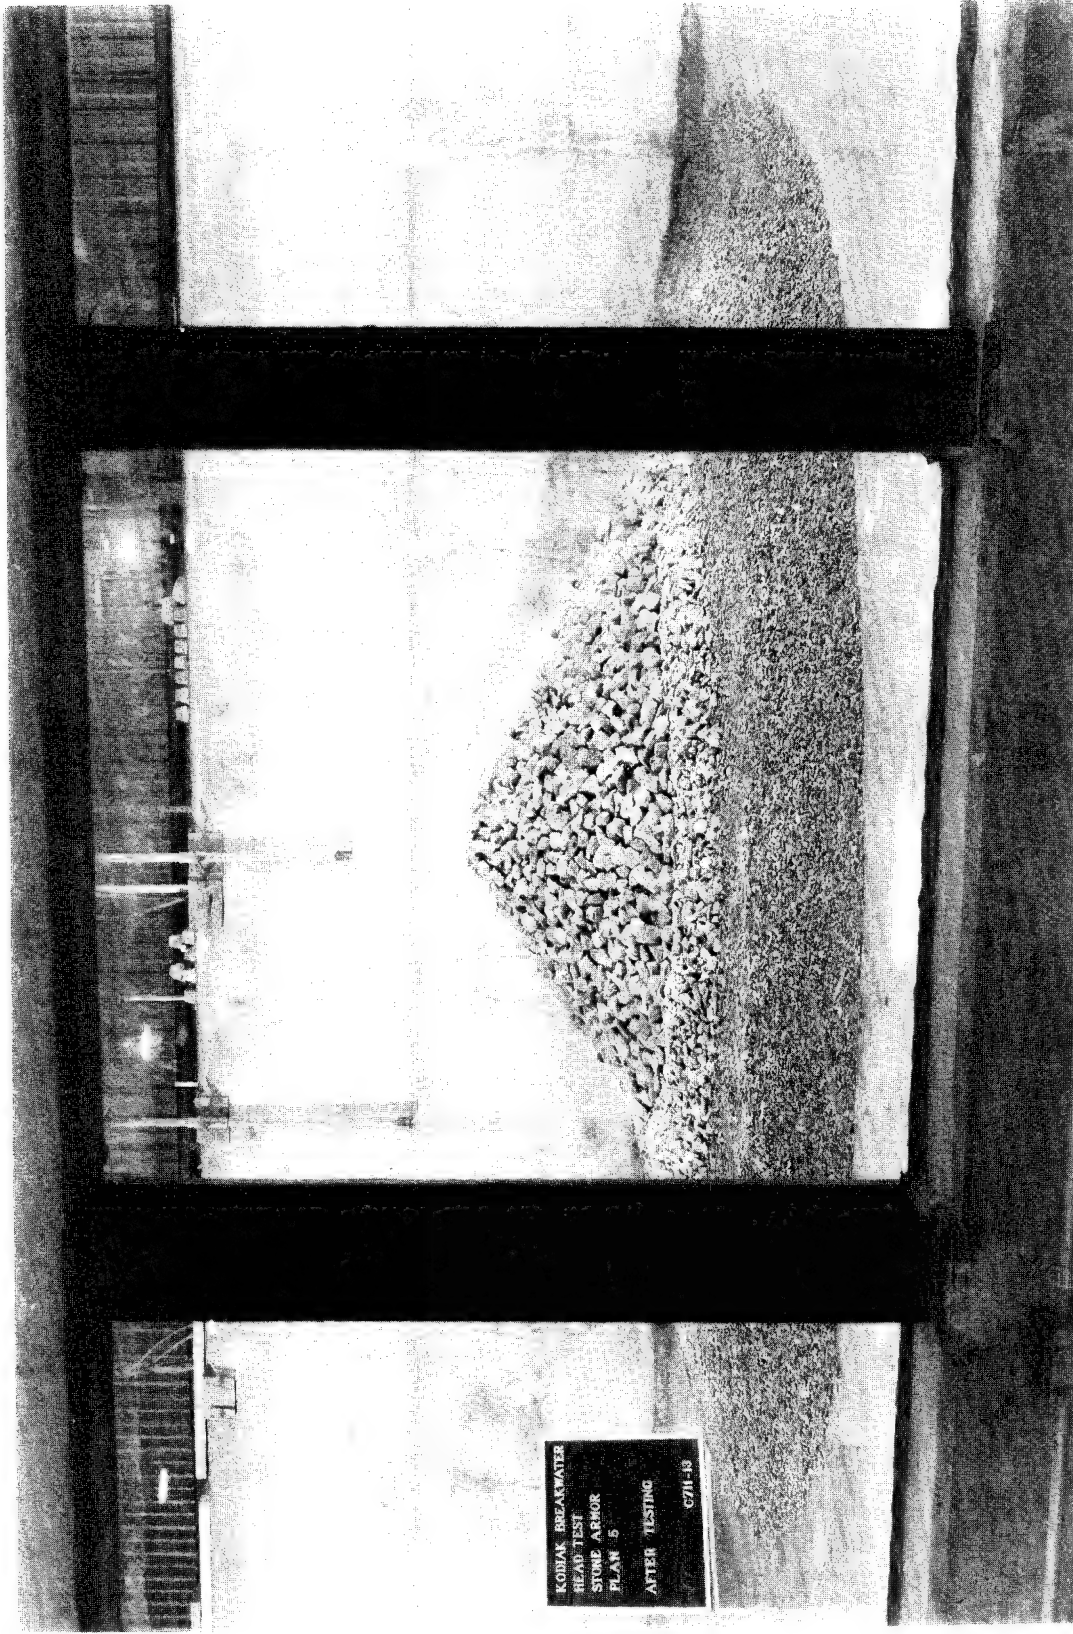
Photo 24. End view of model breakwater Plan 5 after testing

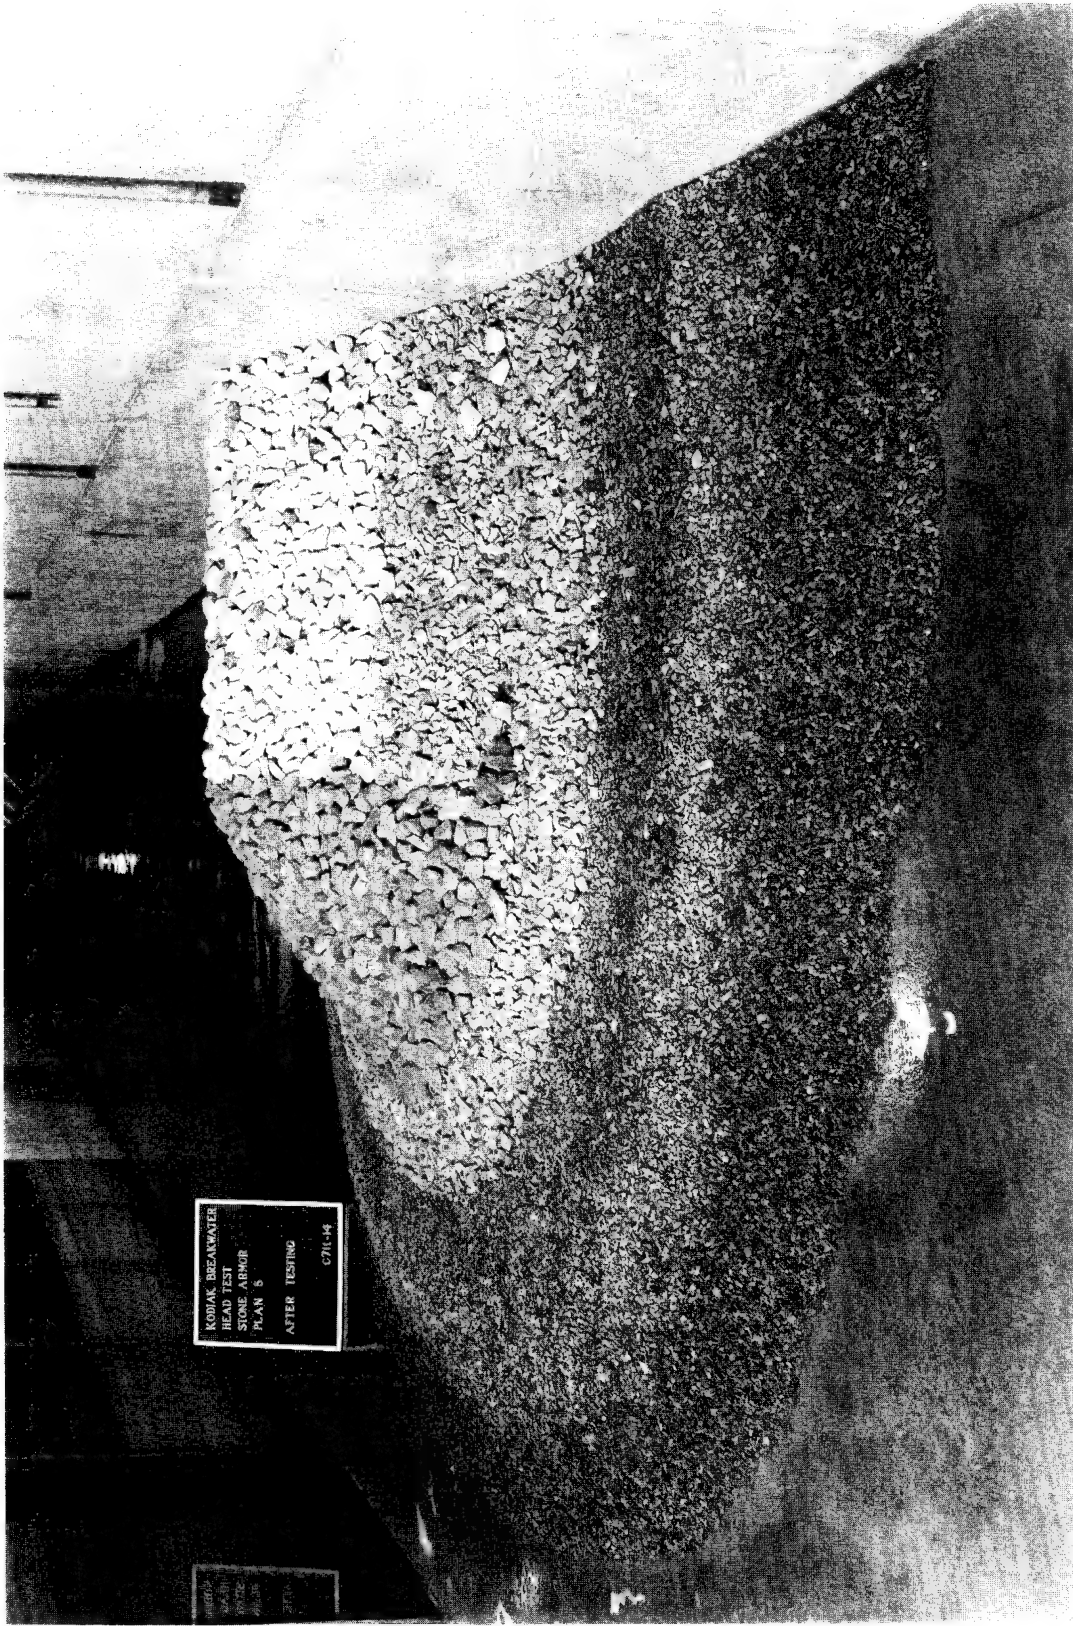
Photo 25. Harbor-side view of model breakwater Plan 5 after testing

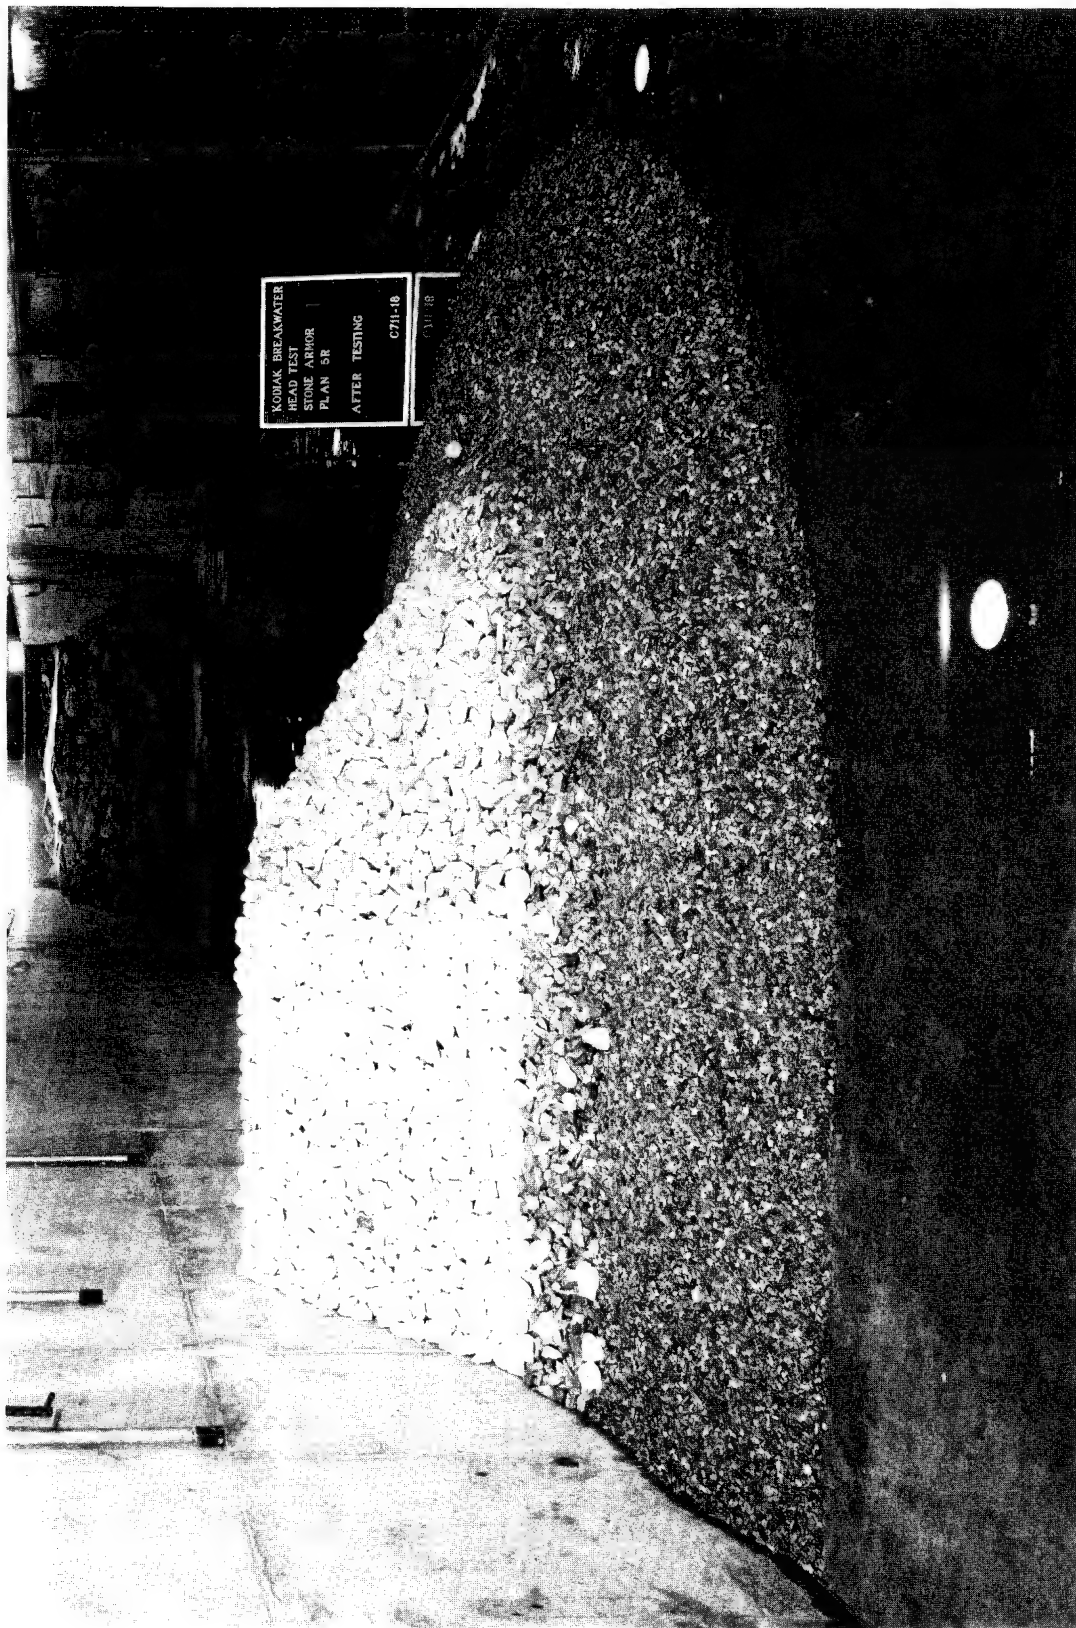
Photo 26. Sea-side view of model breakwater Plan 5R after testing

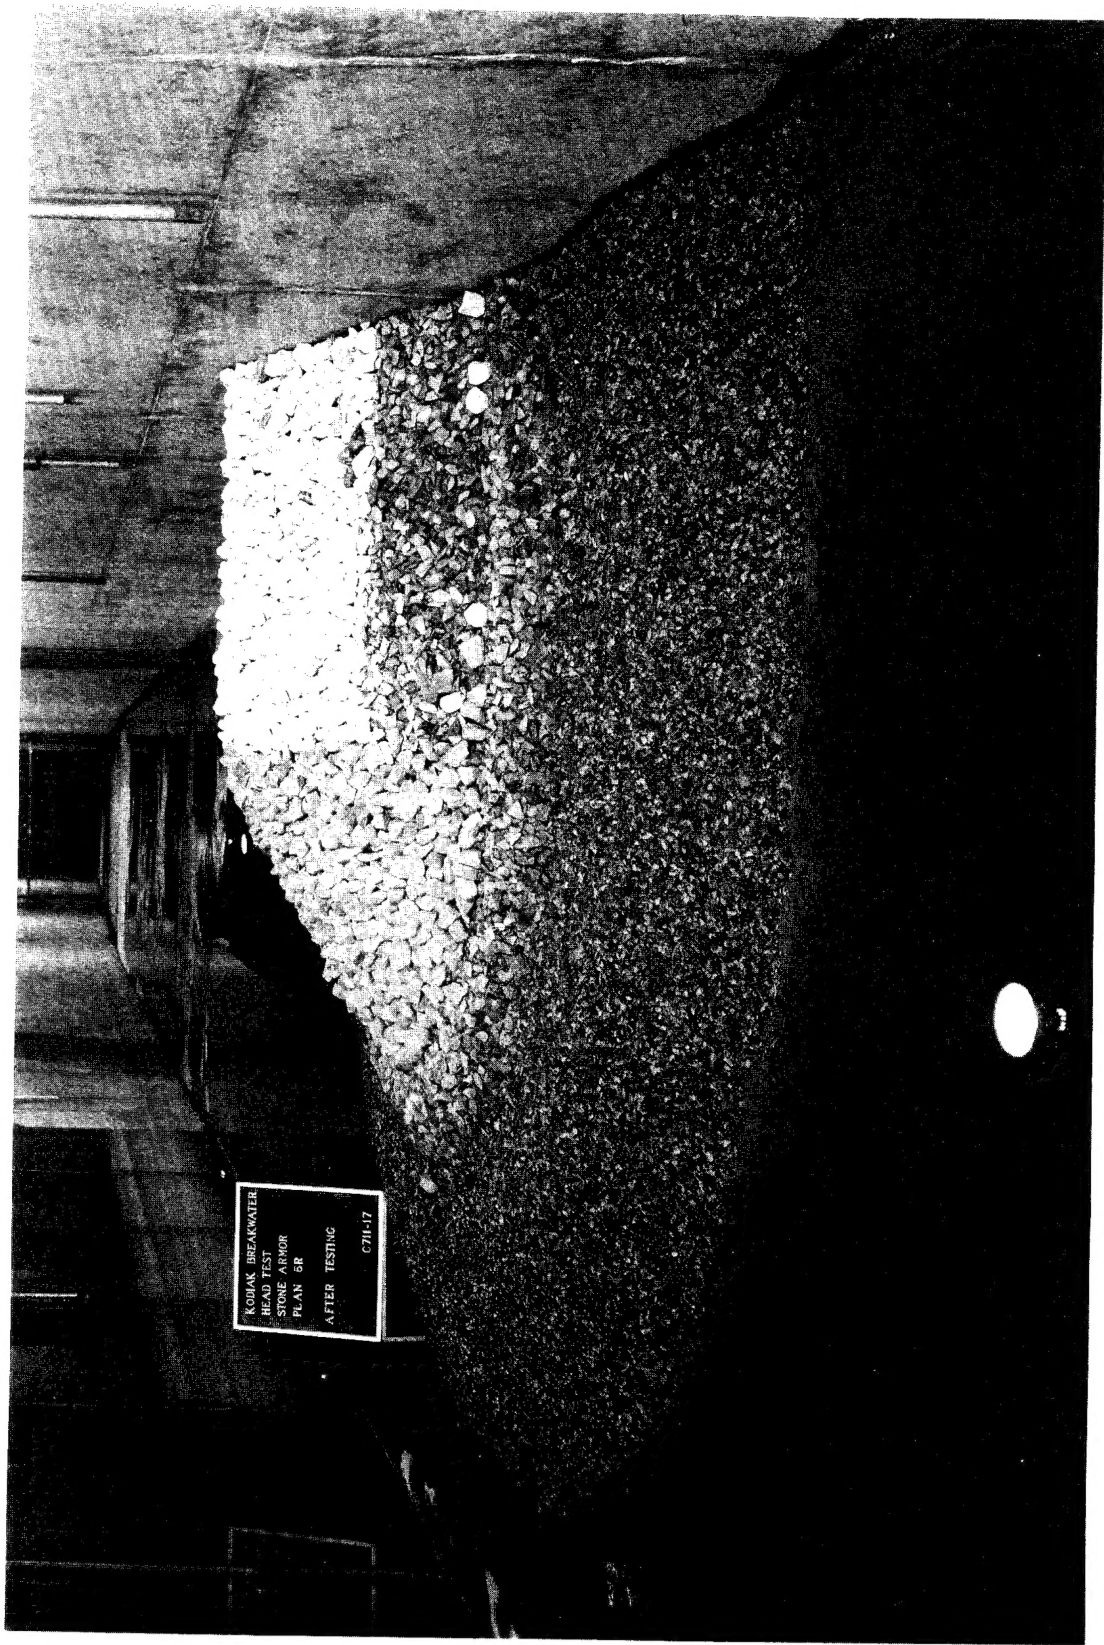
Photo 28. Harbor-side view of model breakwater Plan 5R after testing
